Manhole Inspection Summary

Manhole # S35CC_026MH

Insp Date: **11/25/08 10:23 AM**

Location Address: **24 e eager st**

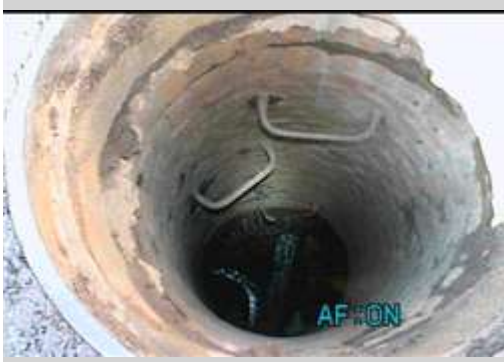
Defect 1

Count: **9** Missing: **4** ☒ **Corroded**

corr steps

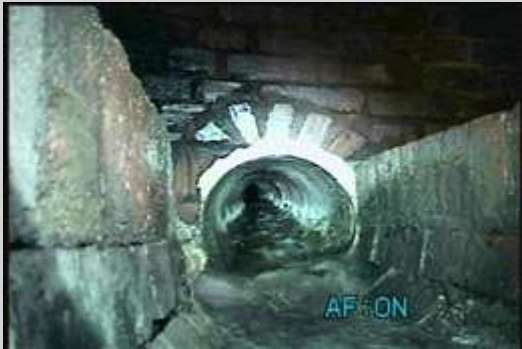
12 O'Clock Outflow

10 in. Circular Gravity Sewer
Pipe Out @ 12 O'Clock

Invert Depth: **13.50** (ft.) Flow Characteristics: **Fast**

Infiltration: **None** Pipe Seal Cond: **Unknown**

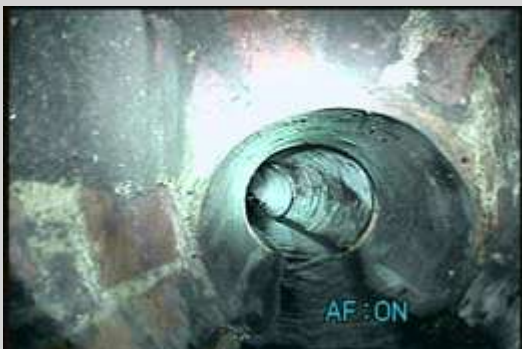
3 O'Clock Inflow

8 in. Circular Gravity Sewer
Pipe In @ 3 O'Clock

Invert Depth: **13.25** (ft.) Flow Characteristics: **Slow**

Infiltration: **None** Pipe Seal Cond: **Unknown**

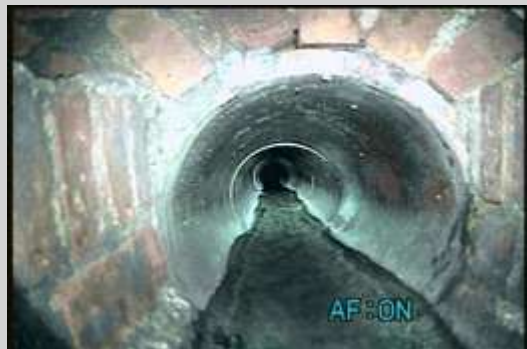
6 O'Clock Inflow

10 in. Circular Gravity Sewer
Pipe In @ 6 O'Clock

Invert Depth: 13.33 (ft.) Flow Characteristics: **Fast**

Infiltration: **None** Pipe Seal Cond: **Unknown**
